Subject: **HIGH FLUTTER WHEN USING "EXT SRC" INPUT**

Model: **APR-5001/5002/5003**

Serial No: **20,201 AND HIGHER (APR-5001)**
20,201 AND HIGHER (APR-5002)
20,401 AND HIGHER (APR-5003)

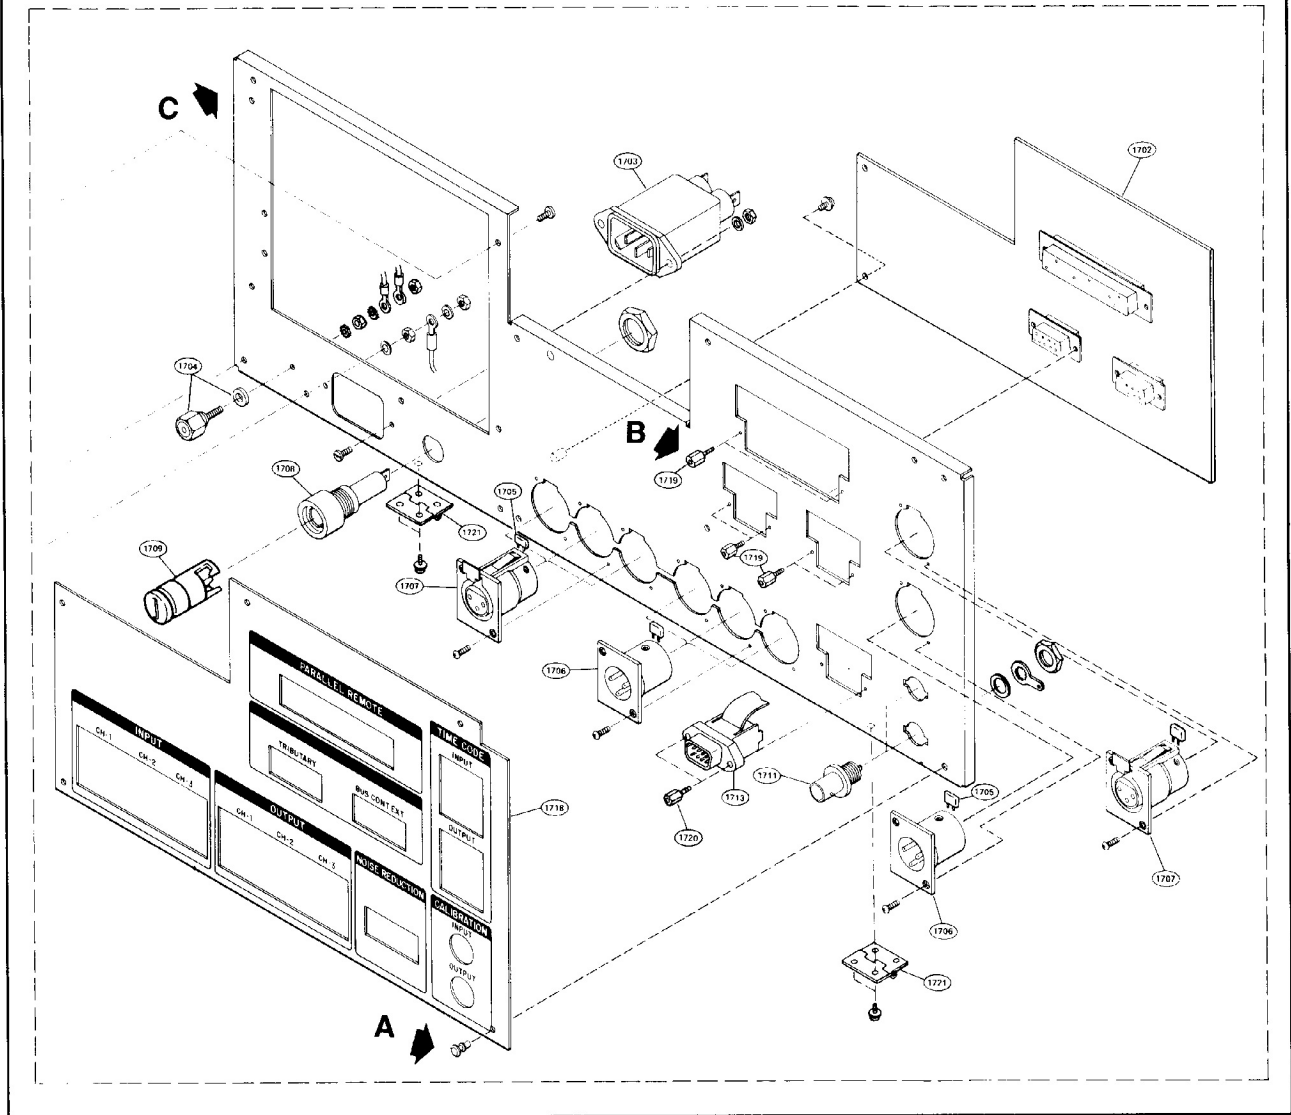
Figure 1

High flutter may occur when using the EXT SRC input. Flutter is caused by a slow rising edge on the output of IC7 on the CNX Board. To correct this problem, modify the CNX Board as described in the following procedure.

1. To access the CNX Board, first remove five pop-in fasteners on rear panel (A).
2. Remove hex screws (6) located on rear panel (B).

3. Open lower rear panel by removing screws (2) located in upper left- and right-hand corners (C). (See Figure 1.)
4. Remove CNX board by first removing screws (2) holding board in place (A). (See Figure 2.)
5. Push connectors out through cutouts so CNX Board can clear lip of outer panel when being lifted out.
6. If CNX board is numbered T-9412-316-1, it will have a 5-pin resistor network (RN1) instead of discrete resistors at R80 and R81. If so, remove IC7 (HCPL-2730) and replace with HCPL-2531 (T-9413-636-1). No resistor changes are needed.
7. If CNX board is numbered T-9412-316-2 through T-9412-316-4, or 1-619-162-11, proceed with steps a and b.
 - a. Remove IC7 (HCPL-2730) and replace with HCPL-2531 (T9413-636-1).
 - b. Remove R80 and R81 (470Ω) and replace with 4.7kΩ resistors.
8. Reinstall CNX Board by repeating steps 1 and 2 in reverse order.
